EVALUATION OF SENSYS WIRELESS VEHICLE DETECTION SYSTEM: RESULTS FROM ADVERSE WEATHER CONDITIONS

Prepared By
Juan C. Medina
Rahim F. Benekohal
Ali Hajbabaie
University of Illinois at Urbana-Champaign

Research Report ICT-11-81

A report of the findings of
ICT-R27-58
**Evaluation of Wireless Detection Systems at
RR Crossings & Signalized Intersections**

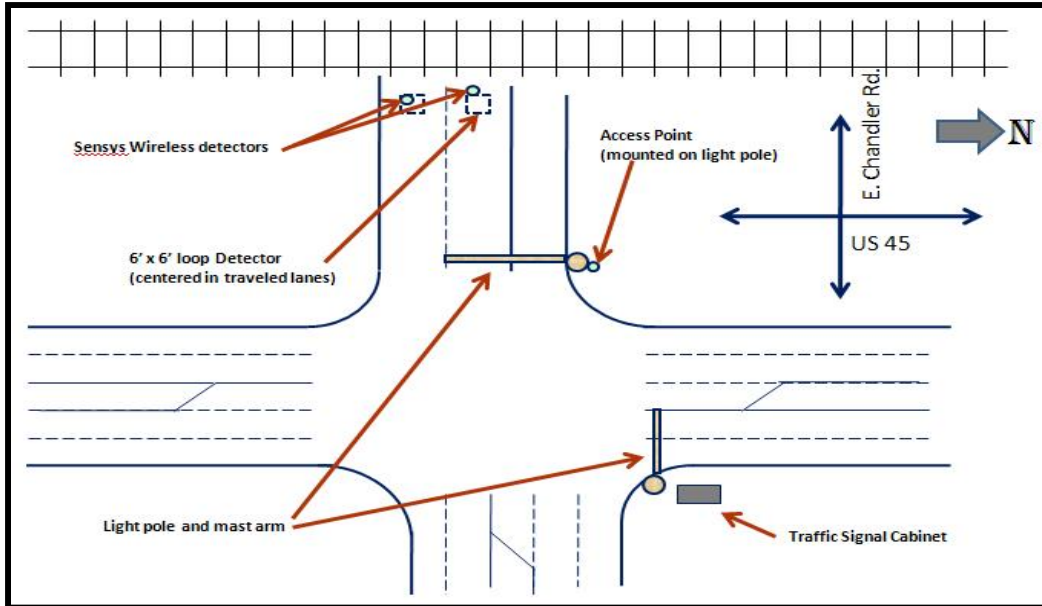
A – Diagram intersection Chandler Rd and Us Route 45.

The evaluation of the Sensys performance was conducted at two locations: 1) the eastbound approach of the intersection of Century Blvd. and Century Pkwy., in the Village of Rantoul, IL; and 2) the railroad grade crossing on Chandler Road, just west of its intersection with Illinois Route 45. A schematic representation of the locations, accompanied by sample pictures, is shown in Figures 1 and 2.

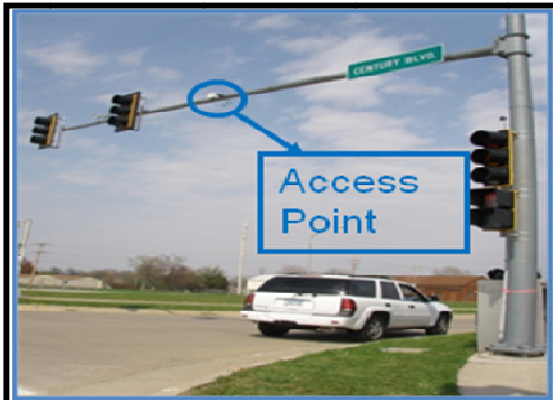
B - Detail access point.

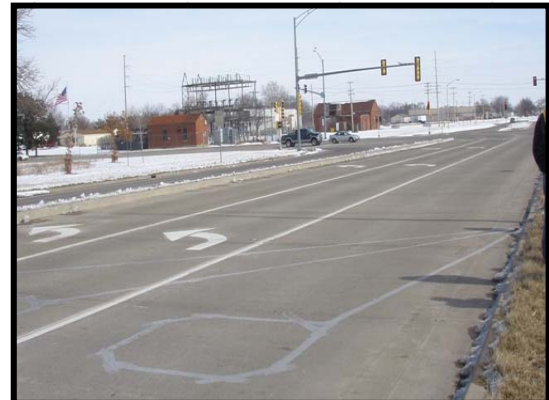
C - Eastbound approach.
